DETAILED SEISMIC ASSESSMENT

Of Primary Structure

Wairarapa Hospital

For Wairarapa District Health Board

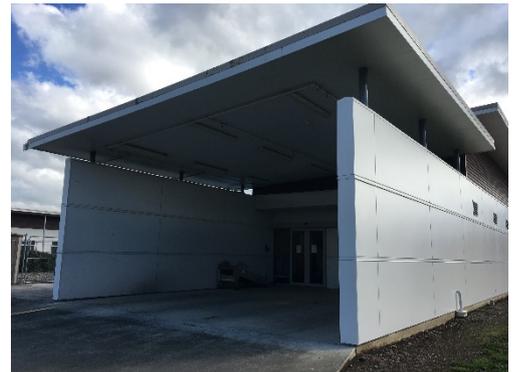
Ambulance Bay

The structural details for the ambulance bay were not included in the original drawing set. The details were issued in a Contract Advice notice to the contractor at a later date.

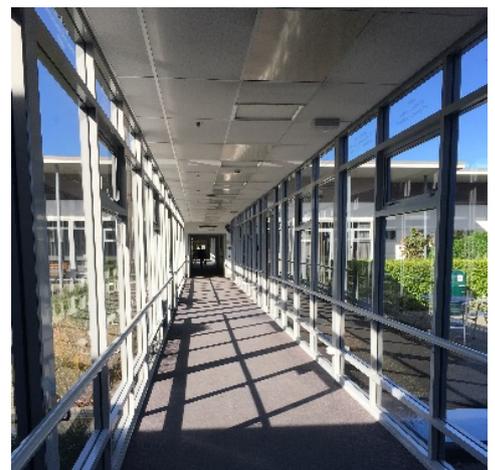
External Glazed wall

At certain locations around the hospital, the external wall line consists entirely of glazing. At these locations there does not appear to be bracing wall elements. As there is no ceiling structure/diaphragm there is no defined primary load path to support the roof and walls under earthquake loading.

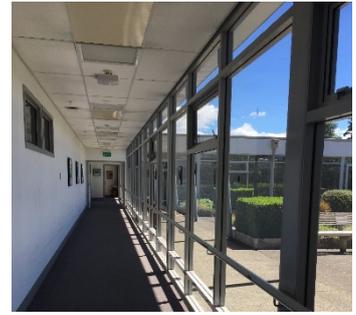
Cafeteria

The cafeteria is not shown on the structural or architectural plans available at the time of writing this report. The external walls of the cafeteria are all glazed, and there is no defined structural system to resist earthquake forces.

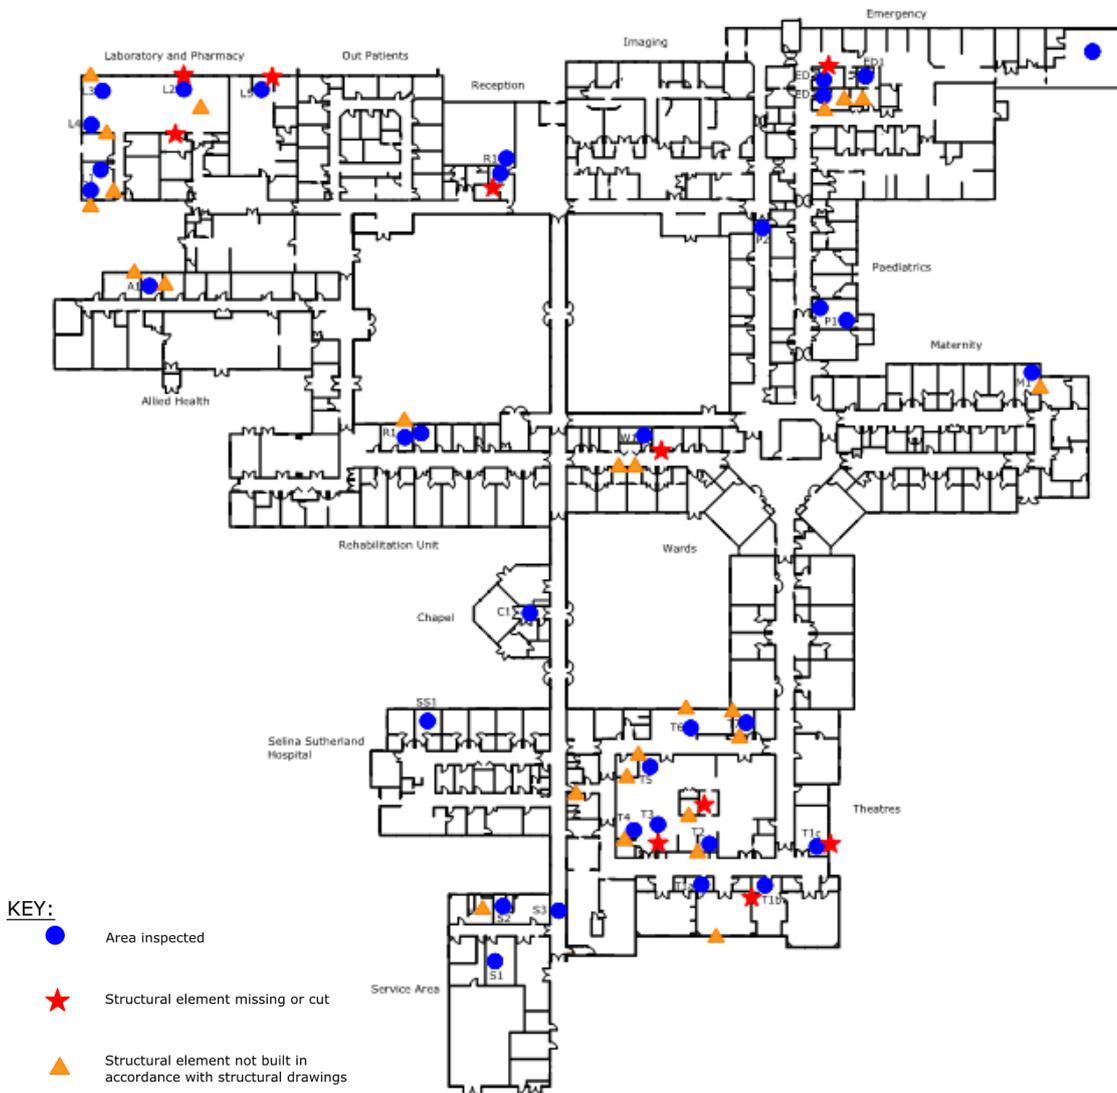
Figure 7 – Floor plan indicating areas inspected, inspections were in roof spaces and focused on roof space bracing, ceiling plane strap bracing and part ply ceiling diaphragm sections.

- Inspections were completed at multiple locations across all wings of the building.
- At most locations there were specific engineer designed roof and ceiling bracing elements that were either cut or were not installed in accordance with the plans.
- Typical specific engineer designed roof and ceiling bracing elements could not be constructed in accordance with the plans at multiple locations. This was generally due to a clash with another architectural or structural element, for example, cross bracing cannot be installed in the same plane as external wall framing.

At these locations, the typical details have generally still been installed, albeit offset from the specified location.

- The services area structural steel is markedly different from the structural plans
