DETAILED SEISMIC ASSESSMENT

Of Primary Structure

Wairarapa Hospital

For Wairarapa District Health Board

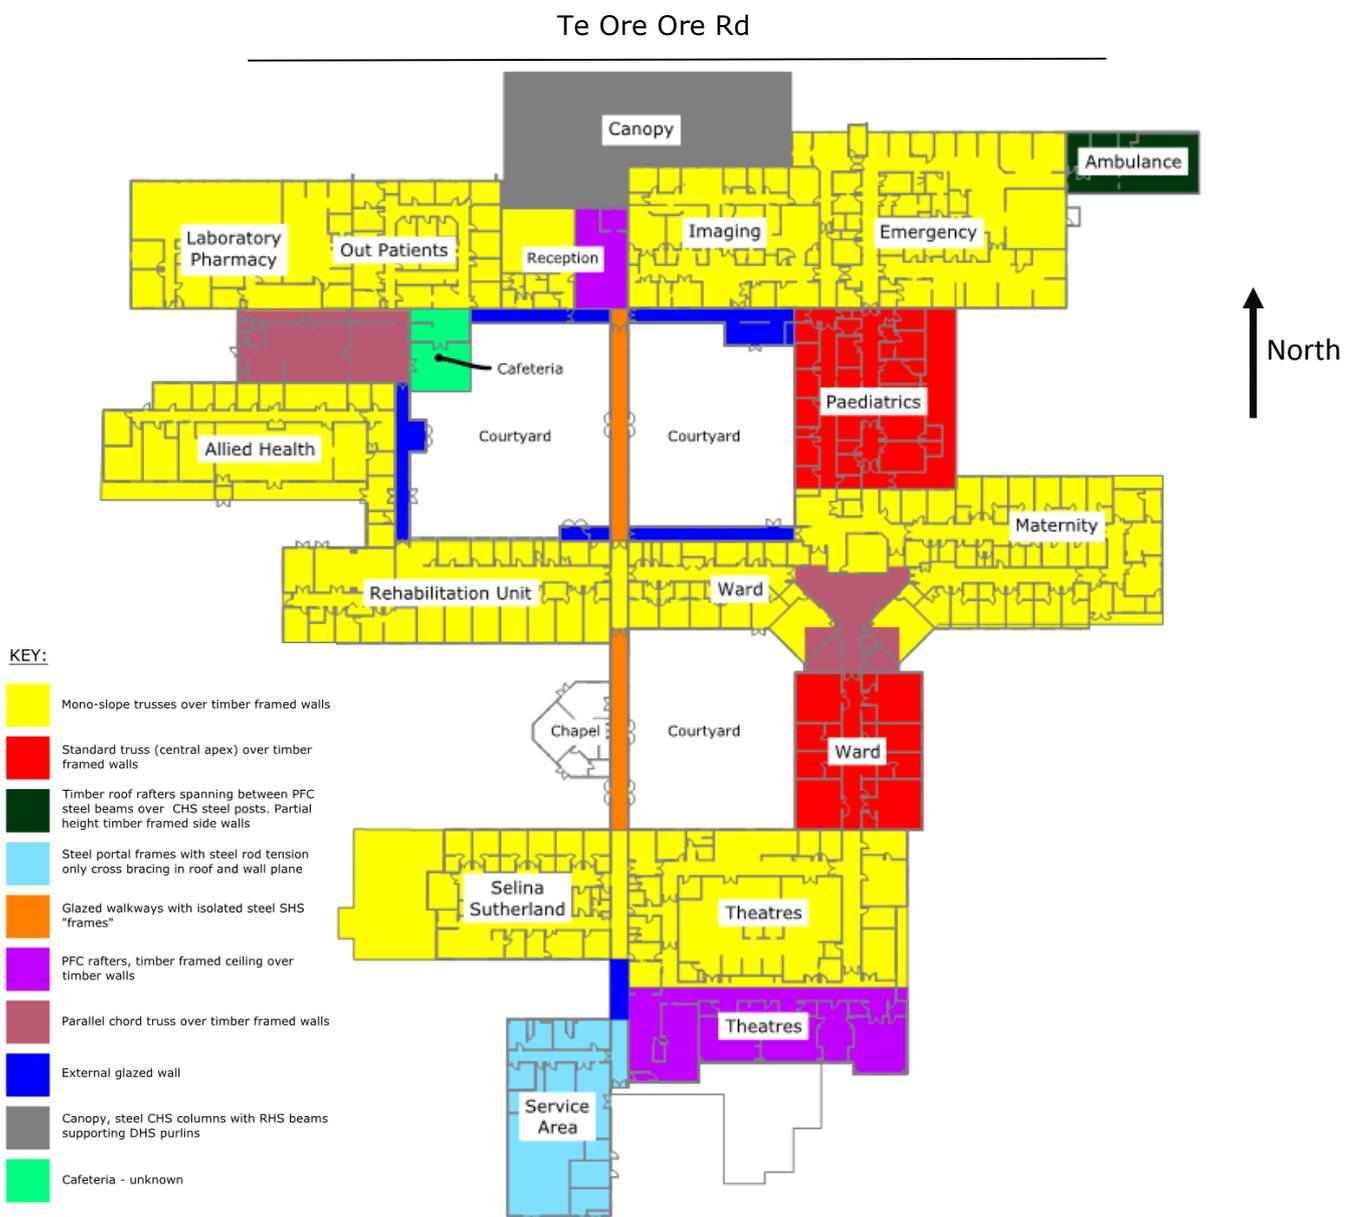
Figure 1 - Floor Plan showing different structural types

The building is a multi-wing single storey building. There are multiple roof configurations and structural types which make up the building, as indicated on the marked up floor plan below;

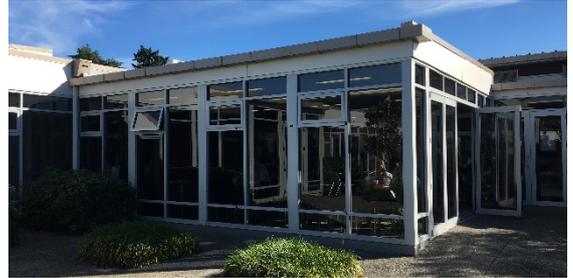
Cafeteria

The cafeteria is not shown on the structural or architectural plans available at the time of writing this report. The external walls of the cafeteria are all glazed, and there is no defined structural system to resist earthquake forces.
